**CWA COMPLIANCE EVALUATION INSPECTION REPORT
U.S. ENVIRONMENTAL PROTECTION AGENCY, REGION 5**

Purpose: Compliance Evaluation Inspection

Facility: Calf Land, LLC.

Date of Inspection: October 31, 2013

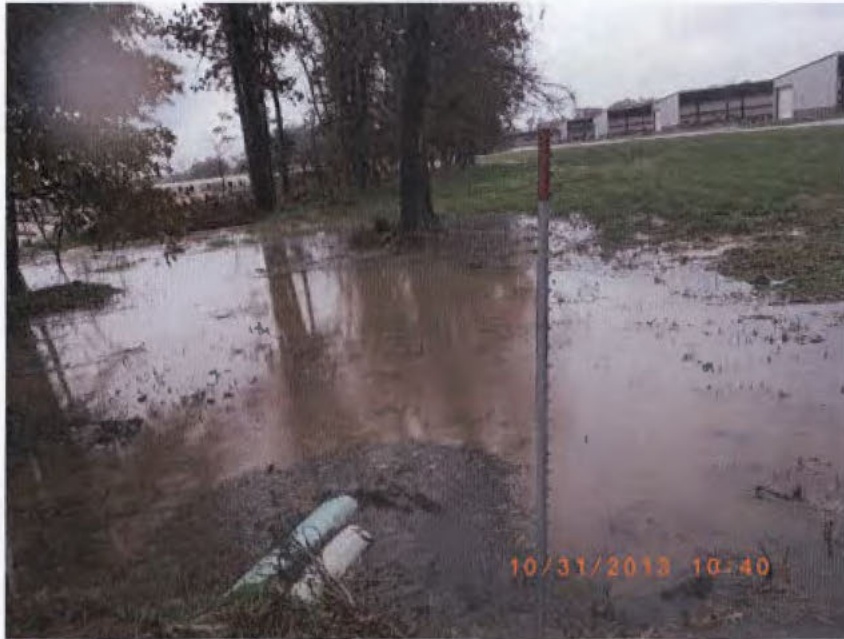
24: IMGP0546

Description: Runoff from the facility flowing south through pipes under access road.

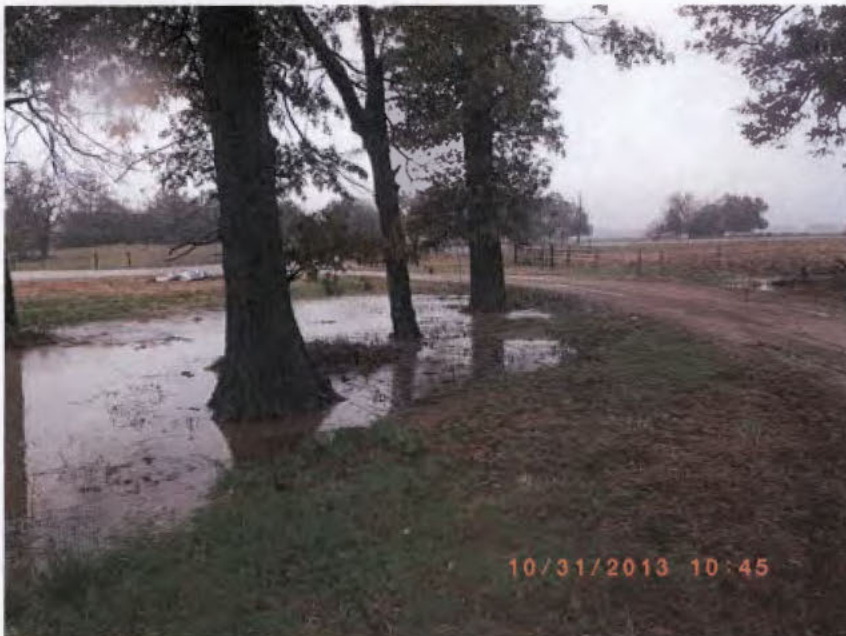
30: IMGP0552

Description: Surface runoff flowing south in grassed swale to the pipes under access road shown in photos 24 and 25.

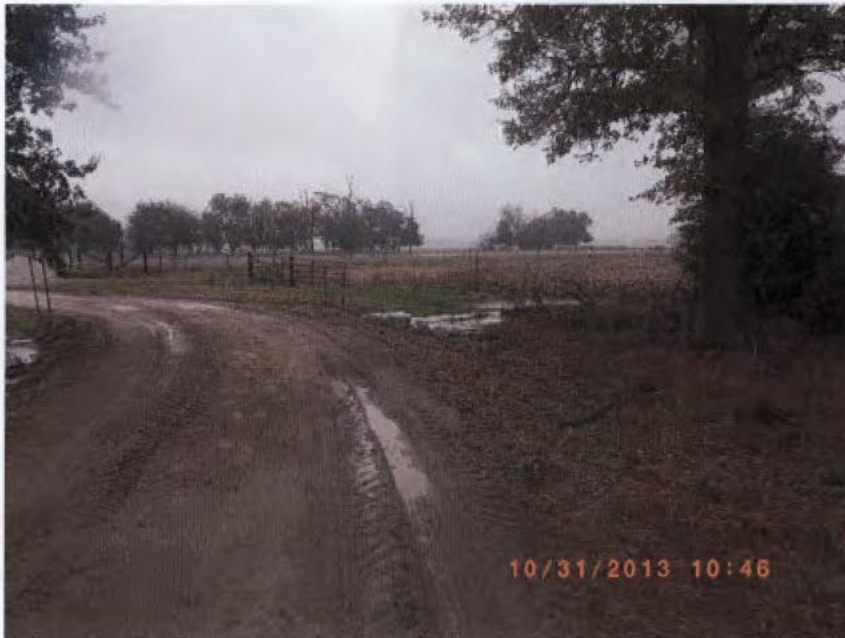
31: IMGP0553

Description: Surface runoff flowing south in grassed swale to the pipes under access road shown in photos 24 and 25.

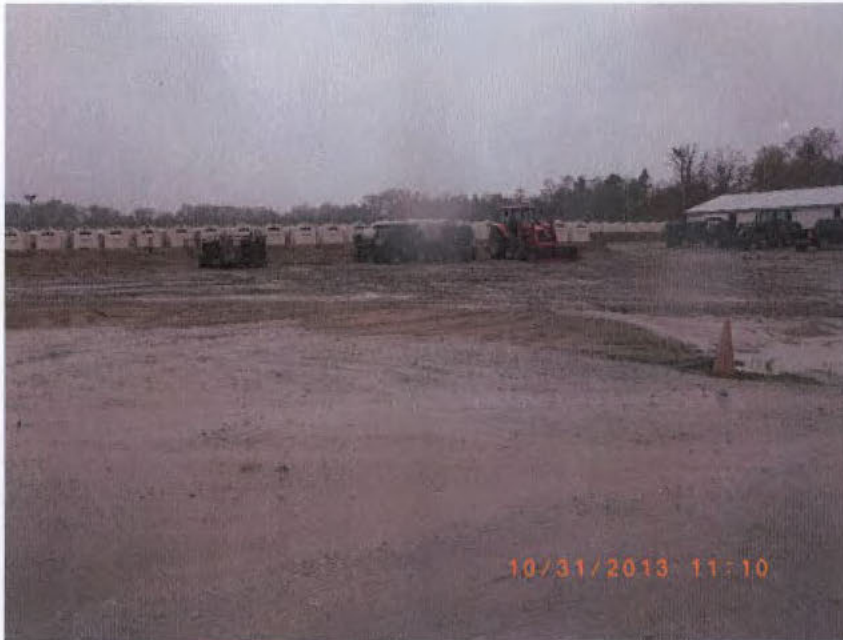
47: IMGP0569

1. Runoff from the Calf Hutch Area is not collected or contained in an approved structure.
2. Runoff collected by manholes located in the roads between pens is not collected or contained in an approved structure.

Description: Surface water flowing to manhole (orange cone) which conveys surface runoff to grassed swale along central access road. Office building in distance.

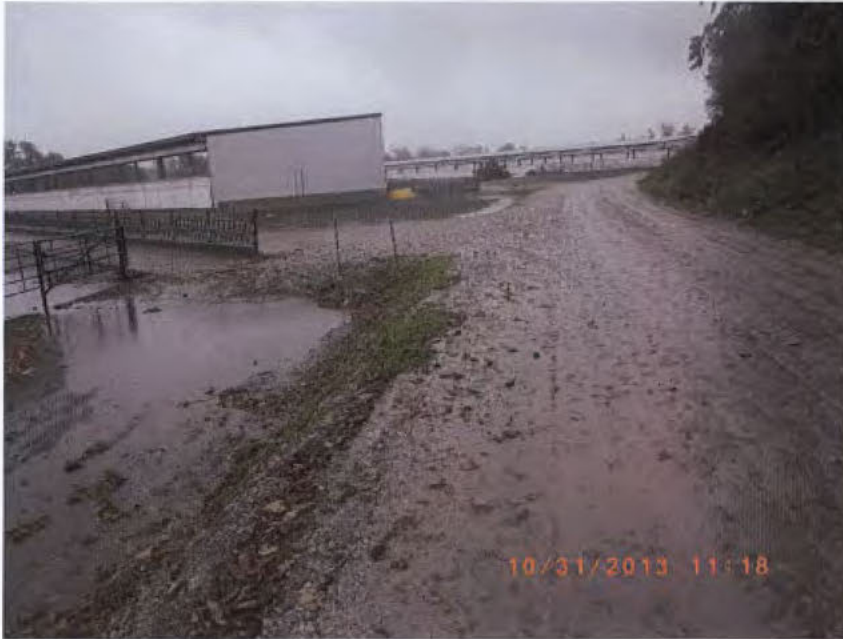
55: IMGP0577

Description: Surface runoff from Pen 7 (left) flowing to ditch on east side of central access road.

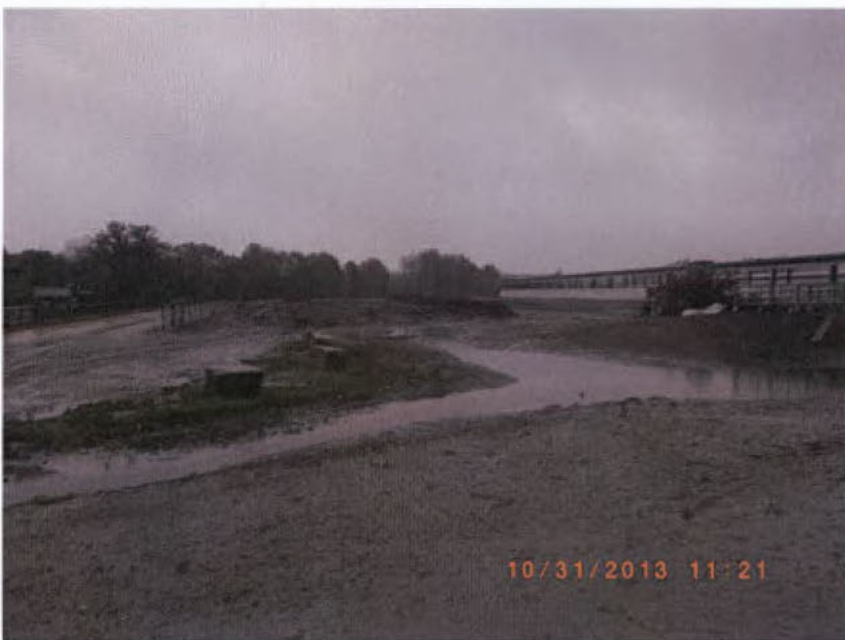
62: IMGP0584

Description: Runoff from composting area flowing to ditch along east side of central access road.

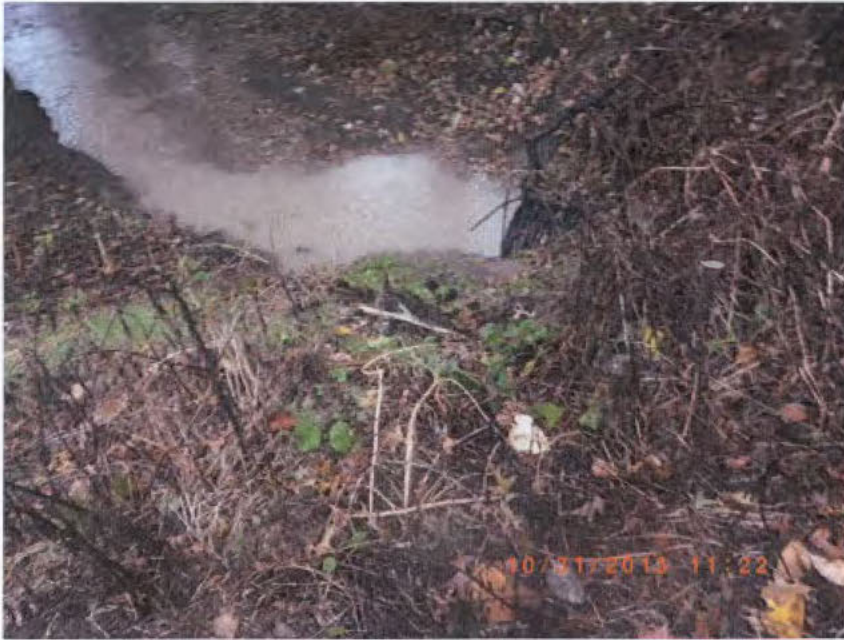
63: IMGP0585

Description: Runoff from composting area flowing to ditch along east side of central access road.

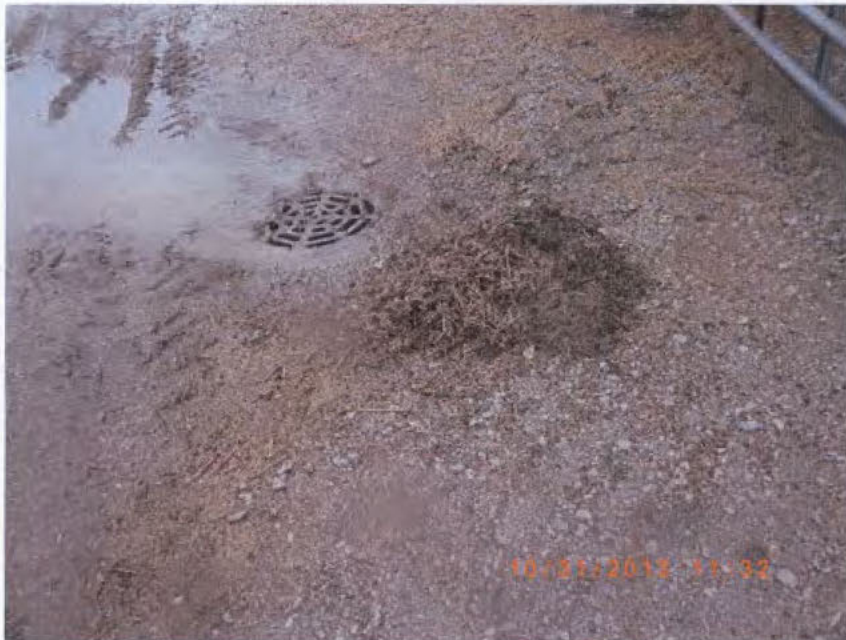
79: IMGP0601

Description: Between pen 3 (left) and pen 2 (right). Arrow points to manhole draining road.

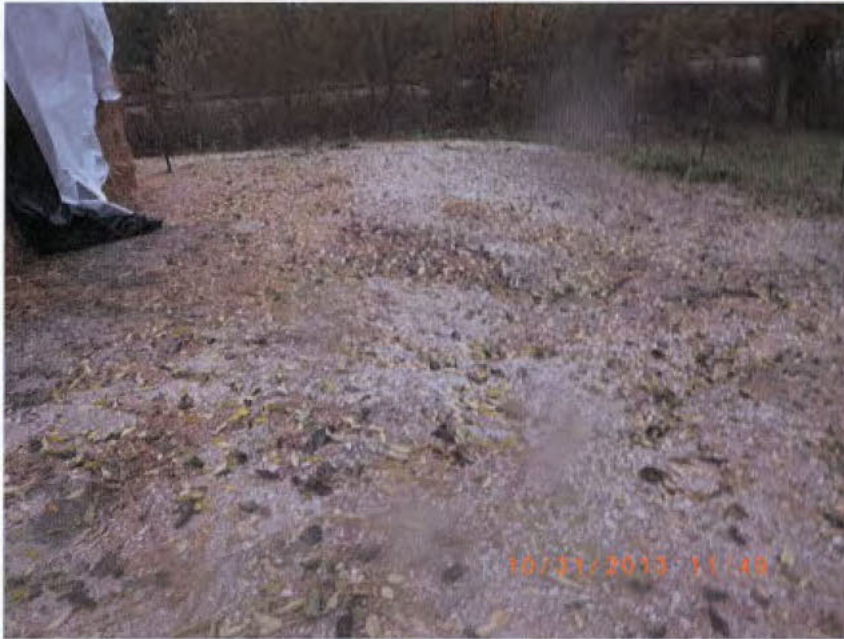
103: IMGP0625

Description: Hay storage on southeast side of pen area.
